ENCAP Visual Field Guide: CONSTRUCTION

for quick identification of serious environmental & occupational health and safety concerns in small-scale construction

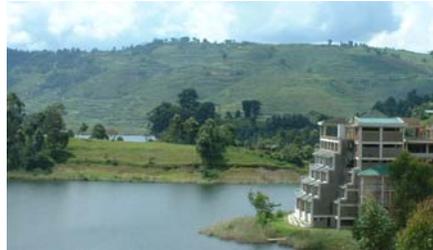
Issue 1: Construction or operation may result in sedimentation or other contamination of the water.

Issue 2: Construction may interfere with drainage of upstream lands.

Image: a new hotel approaches completion on the shore of a fragile freshwater lake.

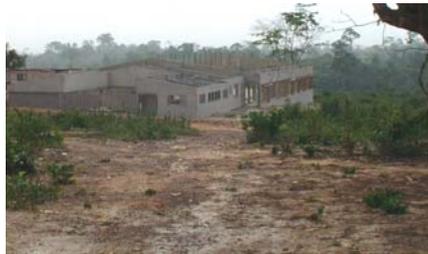
Issue: These sites are high value due to their biodiversity and/or other "ecosystem services" (e.g. flood control, breeding habitat) they provide. Thus, any adverse impacts of facility construction or operation are far more likely to be significant.

Image: a new school site is carved out of a forested hilltop.

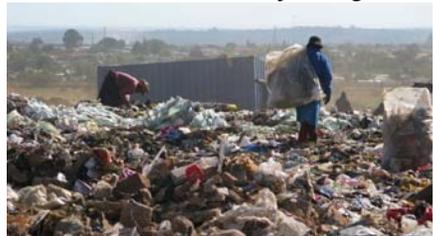
Issue: Hazardous materials such as pesticides may be present that pose a health danger to construction workers and users, particularly if disturbed. There is a higher chance that groundwater is contaminated and unusable. Dump sites attract and breed disease vectors.

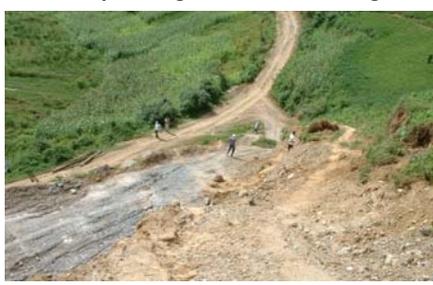
Issue: Strongly sloped sites present high risks for erosion that can permanently degrade the site and runoff that can add sediment load to nearby surface waters and result in gully on adjoining lands & roads.

Image: The view downslope from a hilltop construction site shows erosion and runoff channels.

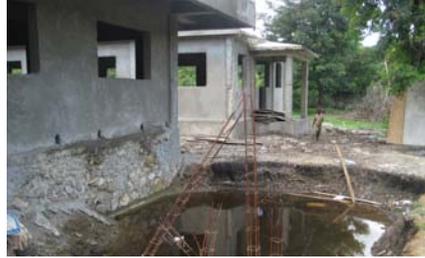
Issue: Standing water breeds insect disease vectors, particularly mosquitoes. It takes 4 days for the malaria-bearing anopheles mosquito to hatch and mature to its flying adult form.

Image: standing water fills a foundation excavation. (Photo: Sun Mountain International.)

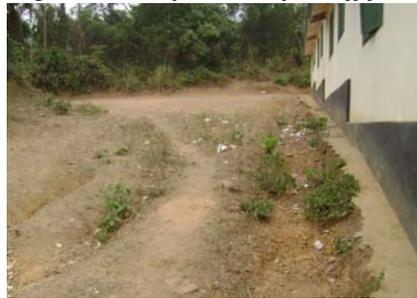
Issue: In addition to permanently degrading the site itself, erosion/runoff from the site can degrade nearby surface waters and damage adjoining lands.

Image: Erosion started on the slope next to this new school during construction & continues now, undercutting the foundation. (Photo: Sun Mountain International)

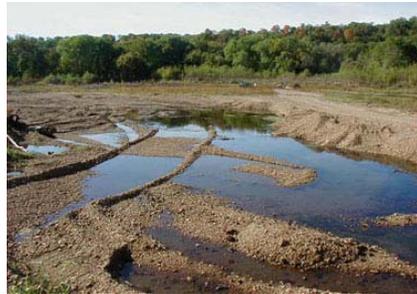
Issue: “Mining” materials from streambeds and wetlands degrades water quality, ruins critical habitat, alters drainage and flow, and can create standing water.

Image: In-stream gravel mining caused erosion and stopped flow in this creek. (Missouri Dept of Natural Resources)

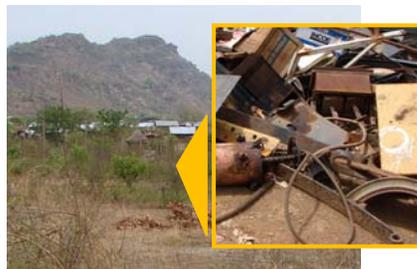
Issue: These wastes can pose physical hazards (e.g. broken glass; rusty torn roofing sheets) and toxic hazards (e.g. leaded paint), and can create breeding habitat for disease vectors.

Image: Open construction waste dump with village in background.

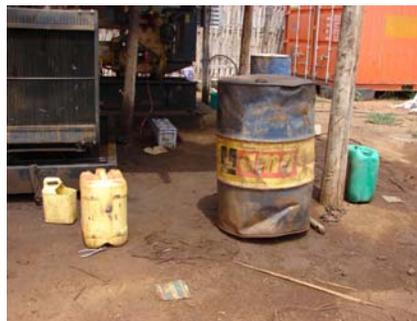
Issue: Such spills can poison soils, surface waters and groundwater.

Image: the ground by this generator shed is stained with fuel and oil spills, despite the slab under the generator itself.

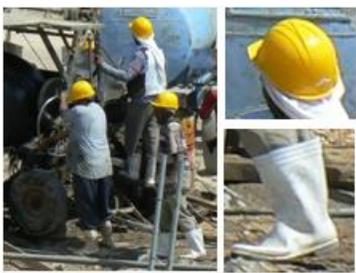
Issue: PPE must be adequate and used consistently to fulfill its intended function: helping protect workers against injuries and disease
NO		Image: unmarked white boots and shiny hardhats indicate that this PPE has been put on for the site inspection.

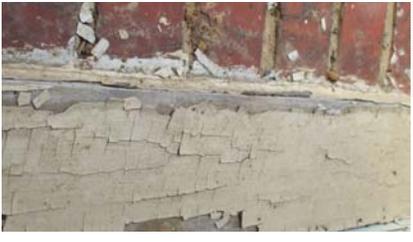
Issue: Paint containing lead is very common in Africa. Scraping or sanding releases lead dust, a toxic health hazard to workers and users of the building. Risks are particularly acute in schools and hospitals.
NO		Photo: Any flaking paint must be scraped during renovation work.
